# Manhole Inspection Summary

Manhole # S23GG1012MH

Insp Date: **12/6/06 3:16 PM**

**Location** Address: **1410 Weldon Pl** Cross Street: **Buena Vista Ave**

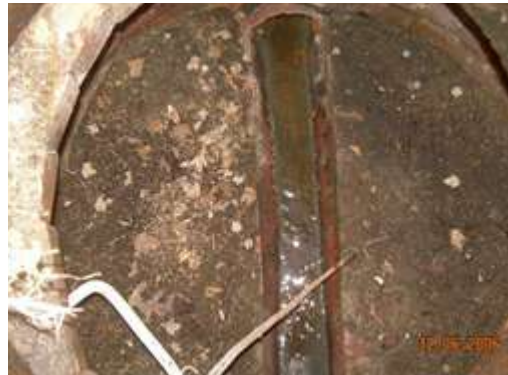
Top View

Bench debris

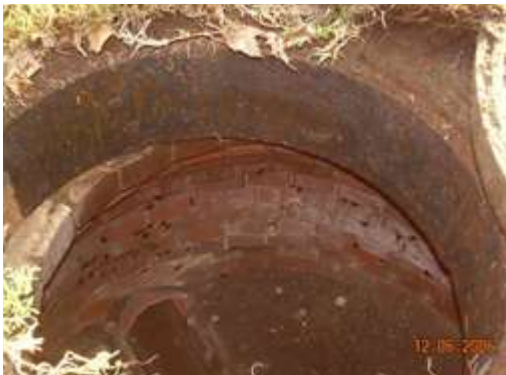
Defect

**Frame** Offset: **2** (in.) Condition: ☐ Sound ☐ Cracked ☒ **Leaks**

Frame leak, adjusment infiltration

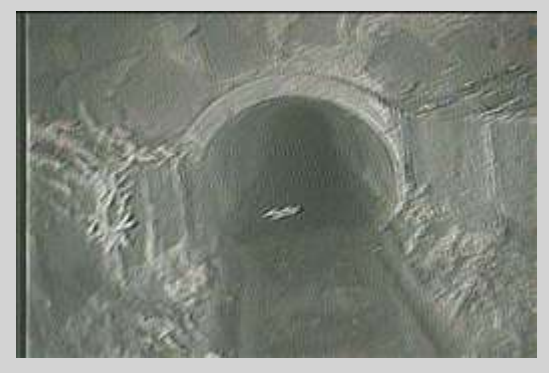
### 8 in. Circular Gravity Sewer Pipe Out @ 12 O'Clock

Pipe Material: **Clay** ☐ Pipe Lined

Invert Depth: **5.72** (ft.) Flow Characteristics: **Slow**

Infiltration: **None** Pipe Seal Cond: **Sound**

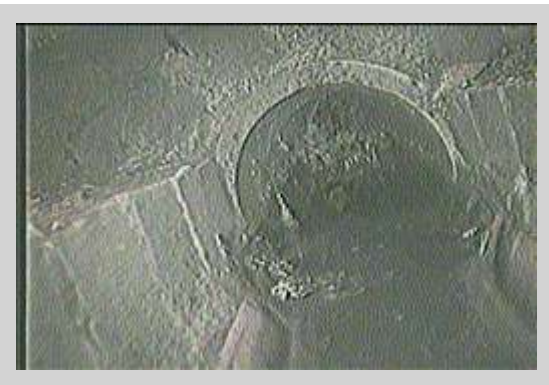
### 8 in. Circular Gravity Sewer Pipe In @ 6 O'Clock

Pipe Material: **Clay** ☐ Pipe Lined

Invert Depth: **5.70** (ft.) Flow Characteristics: **Slow**

Infiltration: **Evidence** Pipe Seal Cond: **Roots**
